AIRCRAFT ACCIDENT REPORT

In-flight Breakup Over the Atlantic Ocean
Trans World Airlines Flight 800
Boeing 747-131, N93119
Near East Moriches, New York
July 17, 1996

**NTSB/AAR-00/03
DCA96MA070
PB2000-910403
Notation 6788G
Adopted August 23, 2000**

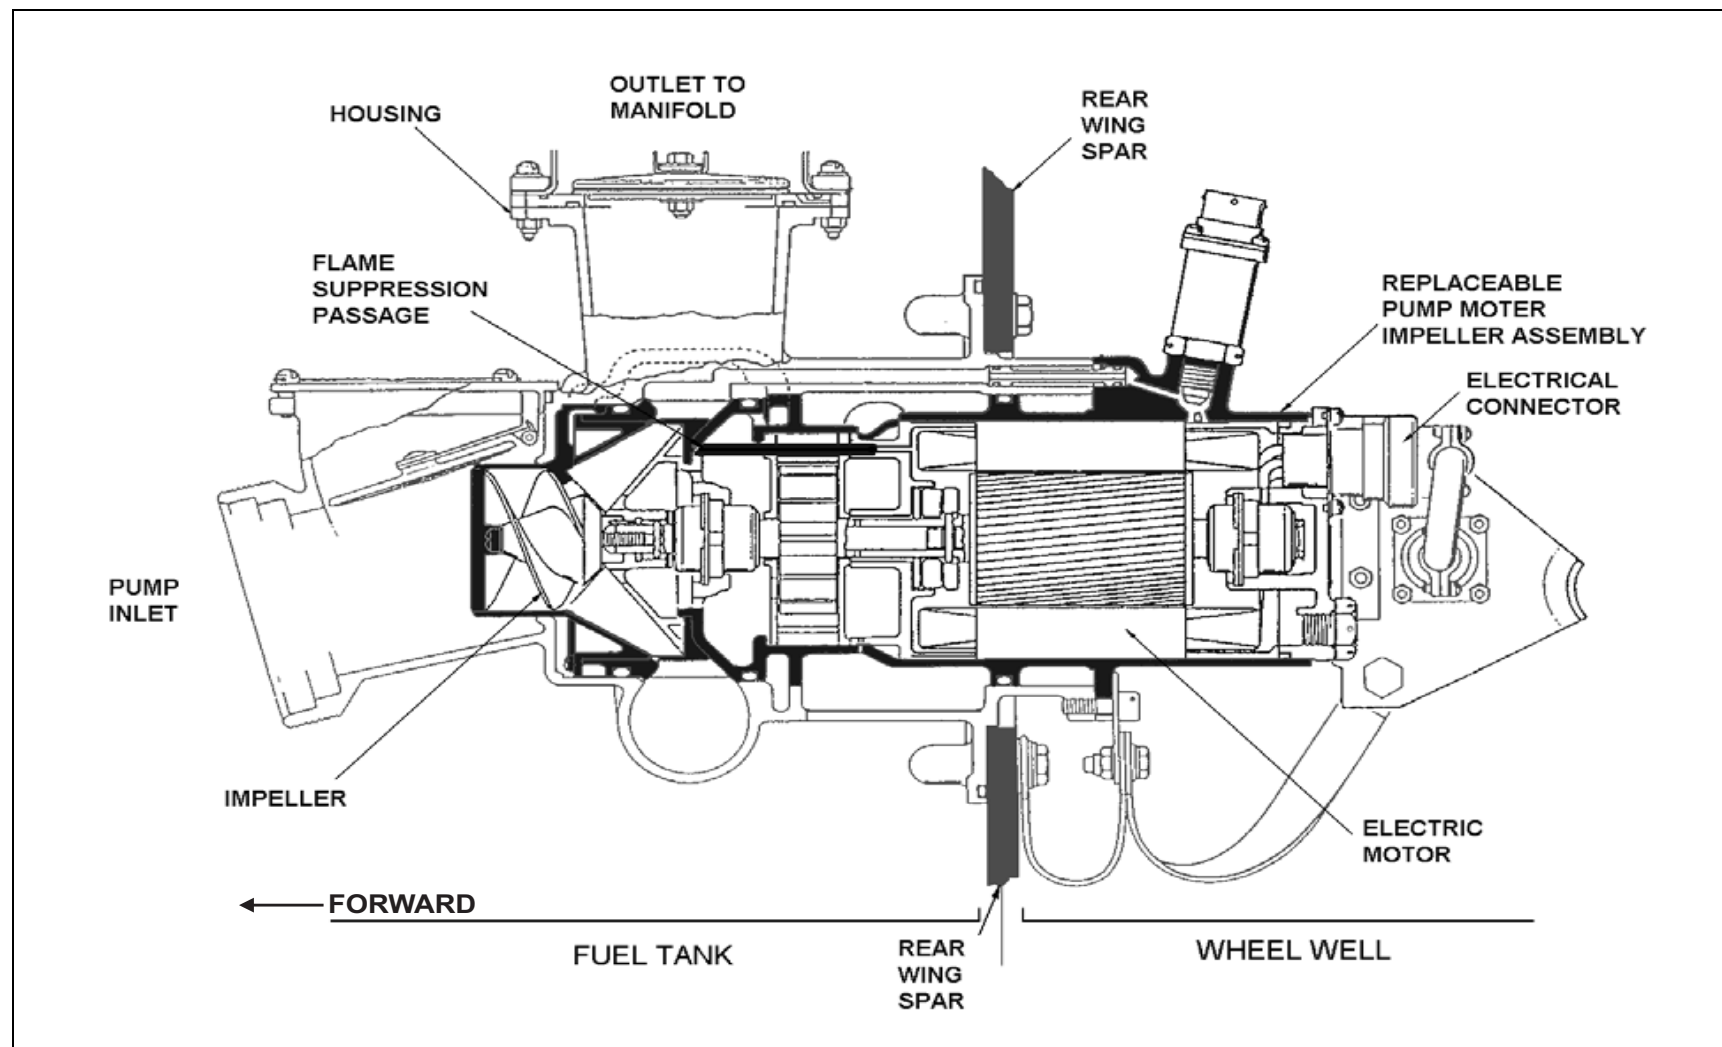
Figure 23. A diagram of a jettison/override fuel pump.

Both jettison/override pumps from the CWT were recovered, examined, and tested. The jettison/override pumps were impact damaged (especially at the aft ends, where they had been attached to the rear spar), but exhibited no evidence of electrical shorts, arcing, preimpact breaching of the housing, or discoloration of the pump shaft. (Figure 23 is a diagram of a jettison/override fuel pump.) Examination revealed that the jettison/override pumps' thermal fuses and flame arrestor tubes were intact and exhibited no evidence of thermal or flame exposure. The CWT jettison/override pump motors exhibited no evidence of heat-related discoloration; the motor windings were the same tan color as those from the wing fuel tanks. (A similar jettison/override pump was heated in a laboratory test until the thermal fuse melted at slightly less than 400° F, and the motor windings were subsequently found to have darkened substantially.)

¹⁴⁷ Similar, but extensively deeper rubbing damage was found in jettison/override pumps in the Philippine Airlines 737 that had a CWT explosion on May 11, 1990. The Safety Board conducted tests for 2 weeks to determine whether galling between aluminum surfaces within the pump could have ignited flammable vapors. The investigative group was not able to ignite flammable vapors by impeller rubbing or by other types of contact between internal fuel pump components.

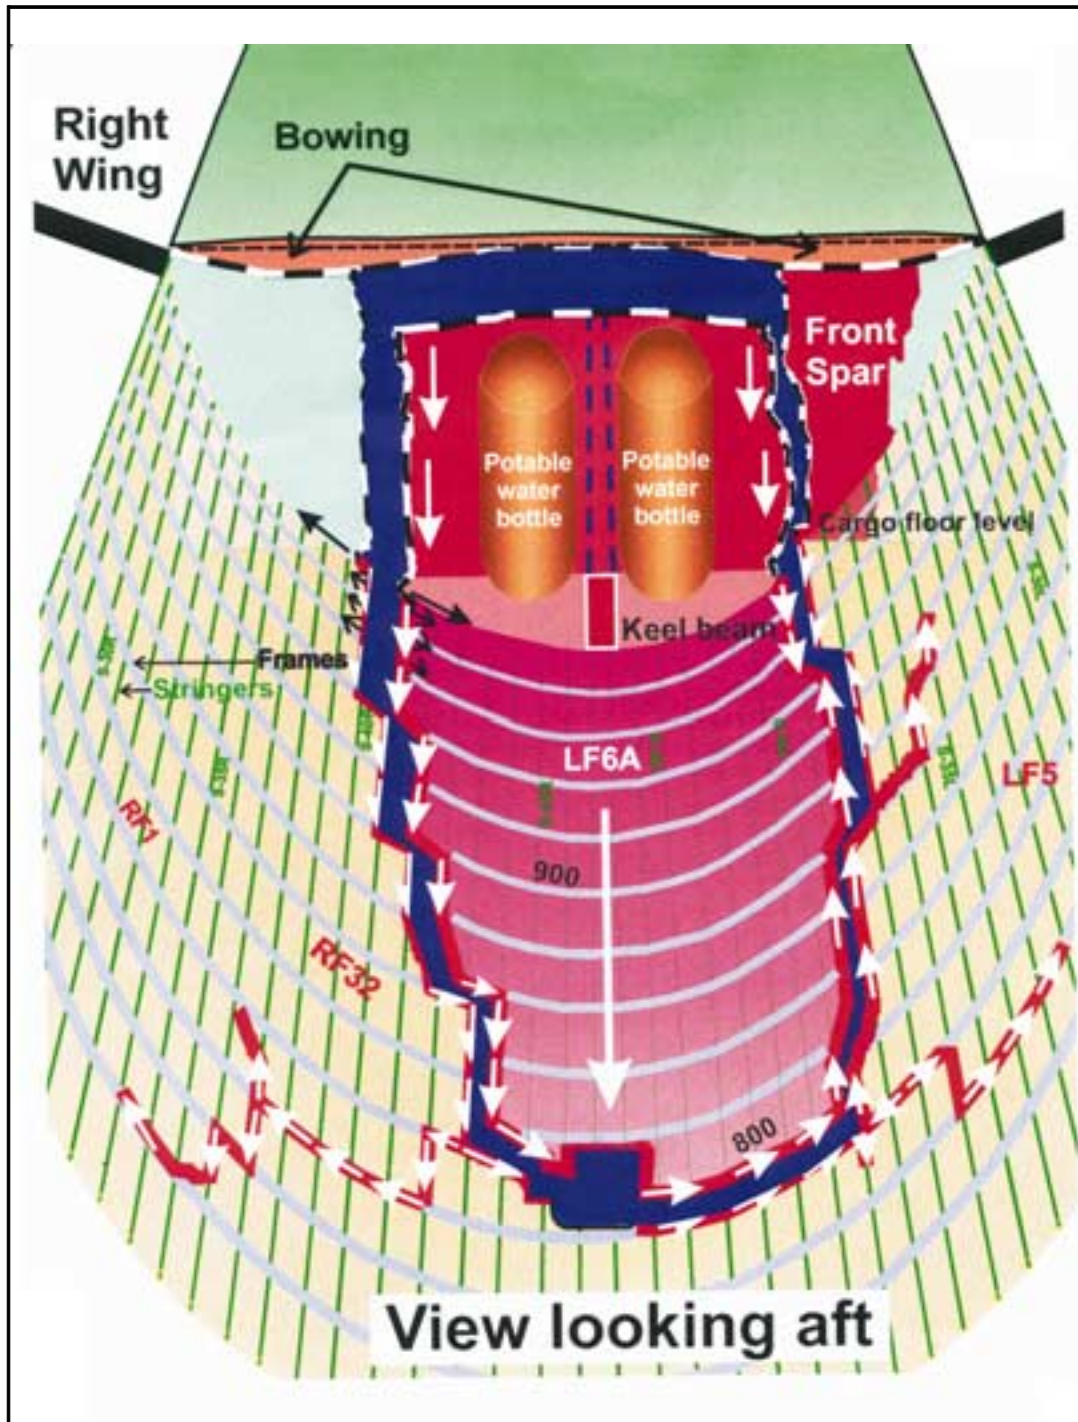
Figure 30. A schematic drawing of the lower portion of the fuselage skin in the area

The detailed examinations of the fuselage red zone pieces are an example of how these examinations were successful in determining an important segment of the breakup sequence. Figure 30 shows a schematic drawing of the lower portion of the fuselage skin in the area forward of the front spar. In this figure, the earlier fuselage skin fractures have been highlighted, and arrows have been added to indicate the direction of cracking in these earlier fractures. Of all of the fuselage fractures examined, only a limited number (all of which were on pieces recovered from the red zone) could be classified as earlier fractures (that is, consistent with in-plane loading). Further detailed examination of the rivet-to-rivet fracture pattern in these earlier fuselage fractures generated information on crack propagation directions and indicated that the earliest fracturing was of the lower fuselage, beginning at the front spar of the WCS. (The methodology used to determine the sequence of fracture in the fuselage red zone pieces was typical of the approach used for the entire airplane structure.)

The Sequencing Group determined that the upper chord of the front spar then completely separated from the WCS upper skin panel, and the overpressure within the CWT forced the WCS lower skin panel and the forward end of the keel beam downward. Stress analysis performed as a part of the sequencing study showed that the continuing downward keel beam motion increased the stresses in the ring chord and fuselage skin adjacent to the front spar. The front spar stiffener at LBL 18 was not bent as far forward as the others, indicating that there was limited forward rotation of the front spar in this area before the ring chord separated at the bottom of the stiffener. Fractures on the right side of the front spar continued into the lower pressure bulkhead,²⁰¹ then continued through the ring chord and into the fuselage skin just in front of the front spar, at stringer 40 right (see figure 30).

On the basis of cracking directions of the fuselage skin, the Sequencing Group determined that the initial fuselage skin cracking (at stringer 40 right just forward of the front spar, about STA 1000) propagated forward and toward the bottom center of the airplane, then continued circumferentially in both directions and back toward the front spar on the lower left side. This fuselage cracking then quickly progressed²⁰² around three sides of a large piece of fuselage belly structure (subsequently identified primarily as piece LF6A). See figure 30 for a diagram of this cracking in the fuselage; piece LF6A is located in the center of this figure.

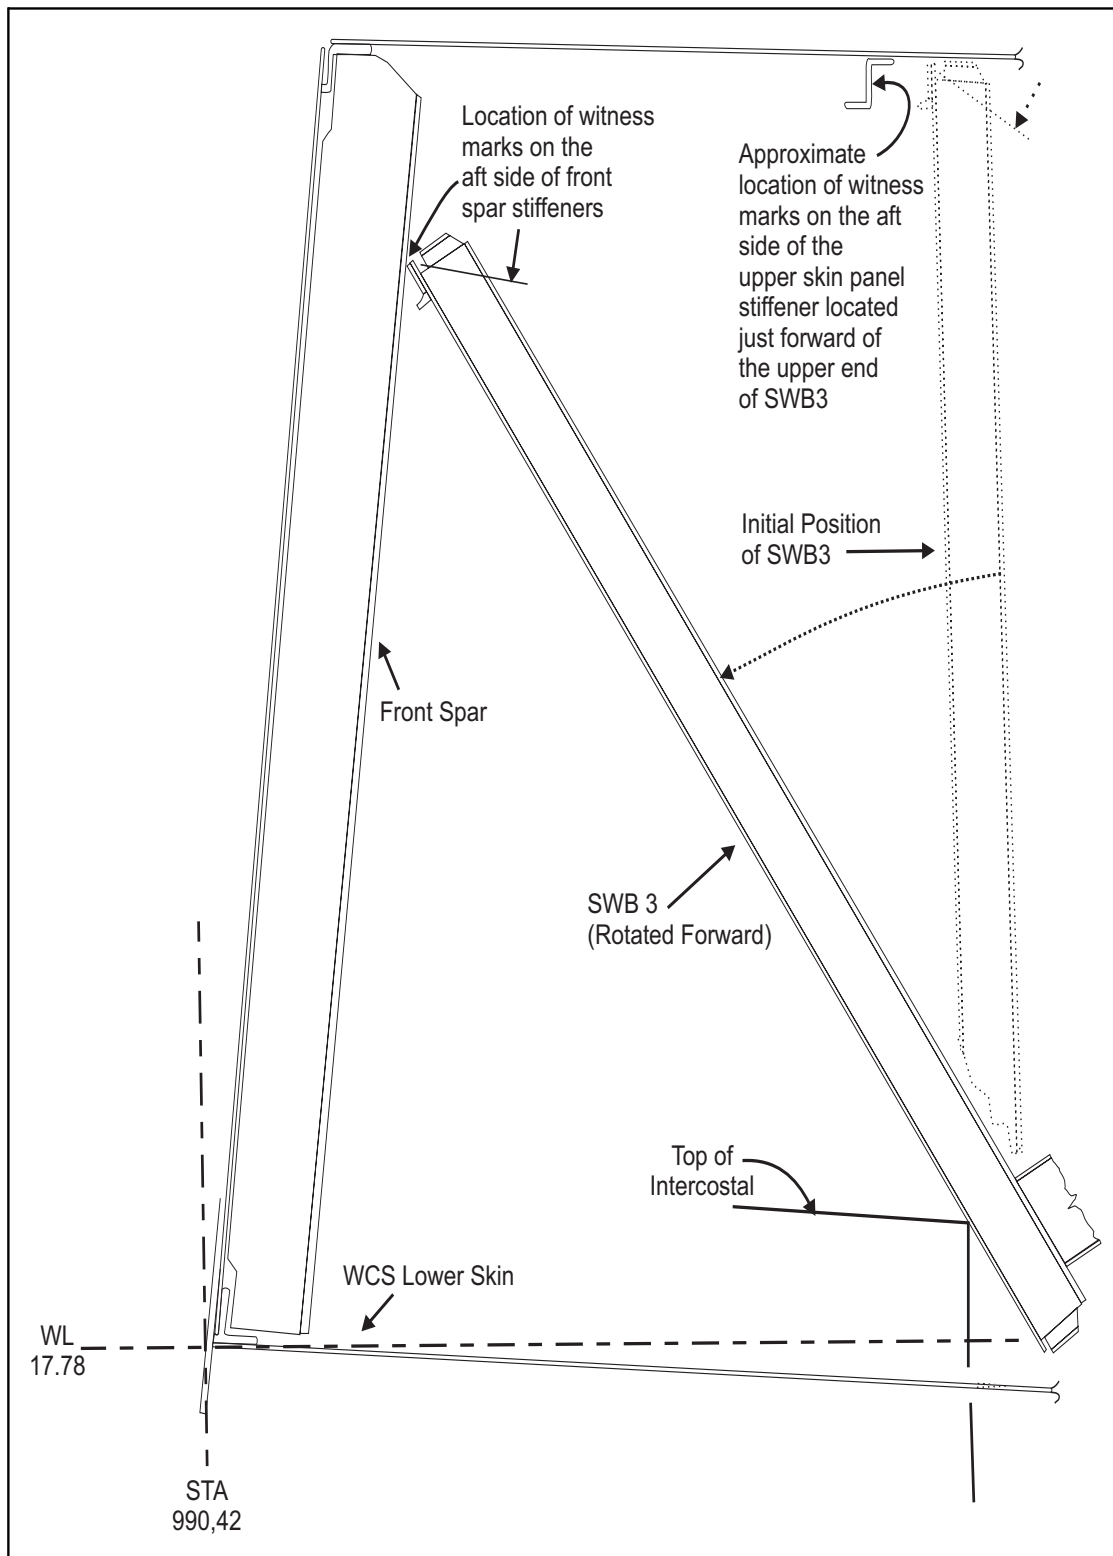
Figure 31. Diagram showing the approximate shape of the upper skin panel stiffener and its location before being struck by SWB3 as the beam rotated forward.

As the upper portion of SWB3 rotated forward, hinging on the still-attached lower chord, the upper chord impacted the aft side of the upper skin panel stiffener immediately forward of SWB3. (Figure 31 shows the approximate shape of this stiffener and its location before being struck by SWB3 as the beam rotated forward.) A geometrical layout of SWB3 and the upper and lower skin panels indicates that the forward rotation of SWB3 about its lower chord would result in an impact on the vertical flange of the stringer about 1.8 inches above the lower edge of the stringer (assuming no relative motion between the upper skin panel and SWB3). However, in the center of this stiffener, a witness mark was

noted at a distance of only 0.9 inch above the lower edge of the stringer. The difference between these values represents an upward vertical displacement of 0.9 inch between the upper and lower skin panels along the airplane's centerline when SWB3 impacted the stringer. The distance of the witness mark from the bottom of the stringer's vertical flange gradually increased at positions further outboard, indicating lesser amounts of upward vertical displacement outboard of the centerline. According to the sequencing study, the location of the marks left on the stiffener by SWB3 indicate that the upper skin of the CWT was likely bowed upward, apparently also as a result of an overpressure event within the CWT.

Continued forward and downward rotation of the top of SWB3 caused the upper end of SWB3 to impact the stiffeners on the aft surface of the front spar about 12 inches below the upper skin panel. This impact left a distinct set of marks on the front spar and initiated multiple failures near the top of that spar. (Figure 31 also shows the approximate orientation between the front spar and SWB3 as the aft side of the front spar was impacted by the upper end of SWB3.) Geometric evaluation and physical evidence indicated that the front spar was intact and in place when it was contacted by the upper end of SWB3. (The location of these SWB3 impact marks on the front spar was a major factor in the Sequencing Group's determination that fracture of the upper portion of SWB3 was the initial failure in the airplane structure.)

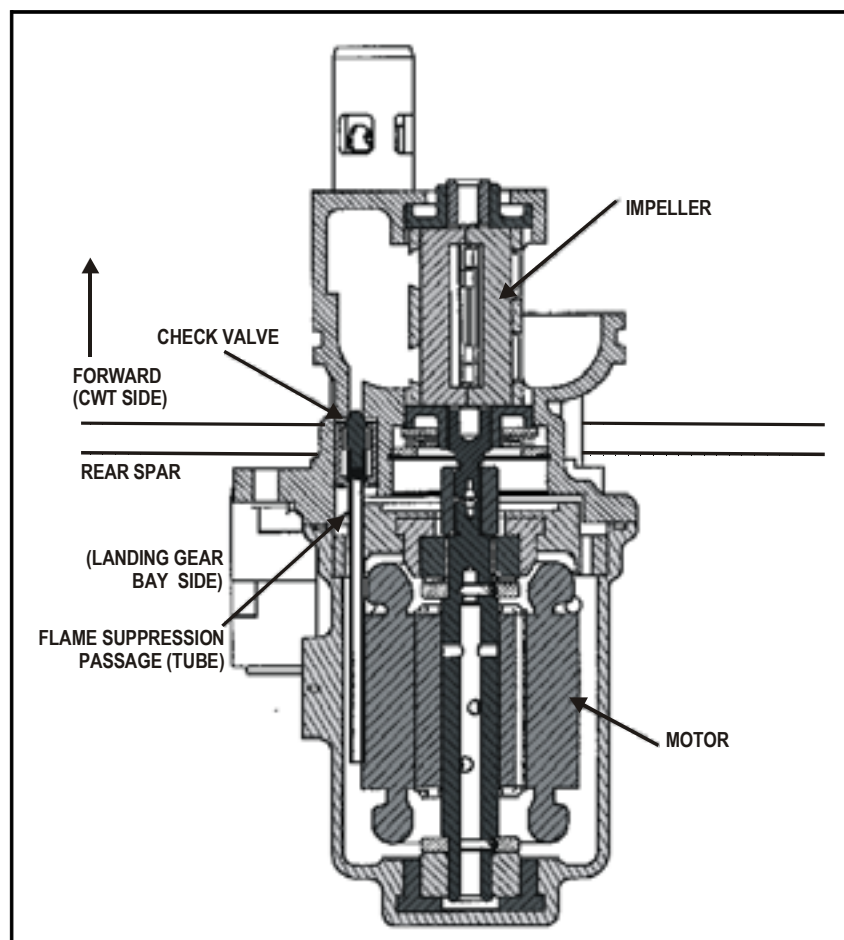
Figure 37. A diagram of a scavenge pump.

contained multiple explosions that were intentionally ignited within the pump motor cavity, preventing the ignition from transferring to the fuel tank. (Figure 37 is a diagram of a scavenge pump.) Because the Board became aware of instances in which the flame arrestor tube was broken or missing, investigators also conducted a series of tests to determine whether the scavenge pump motor housing would contain explosions with only one of the flame suppression system components (either the flame arrestor tube or the check valve) functioning. In all tests, the scavenge pump housing contained the explosions, and the explosive atmosphere surrounding the test pump did not ignite.

During its postaccident examination of other transport-category airplanes, the Safety Board observed that components in the electrical connector on a scavenge pump in a retired 747 were deteriorated. (Boeing ASBs 747-28A2194 and 747-28A0043, both dated January 18, 1996, “encouraged” operators to inspect for degradation in connectors.) Investigators observed that several scavenge pump electrical connectors had been manufactured of a material that degraded with long-term exposure to fuel. Boeing provided the Board with a service history for the 747 scavenge pump for the 10 years preceding the accident. When queried about the brevity of this history, Boeing indicated that most operators did not return the scavenge pumps to the manufacturer for overhaul.

As a result of these findings, Boeing issued ASB 747-28A2206, dated September 25, 1997, and AD 97-25-06, effective December 16, 1997. AD 97-25-06 contained the following summary:

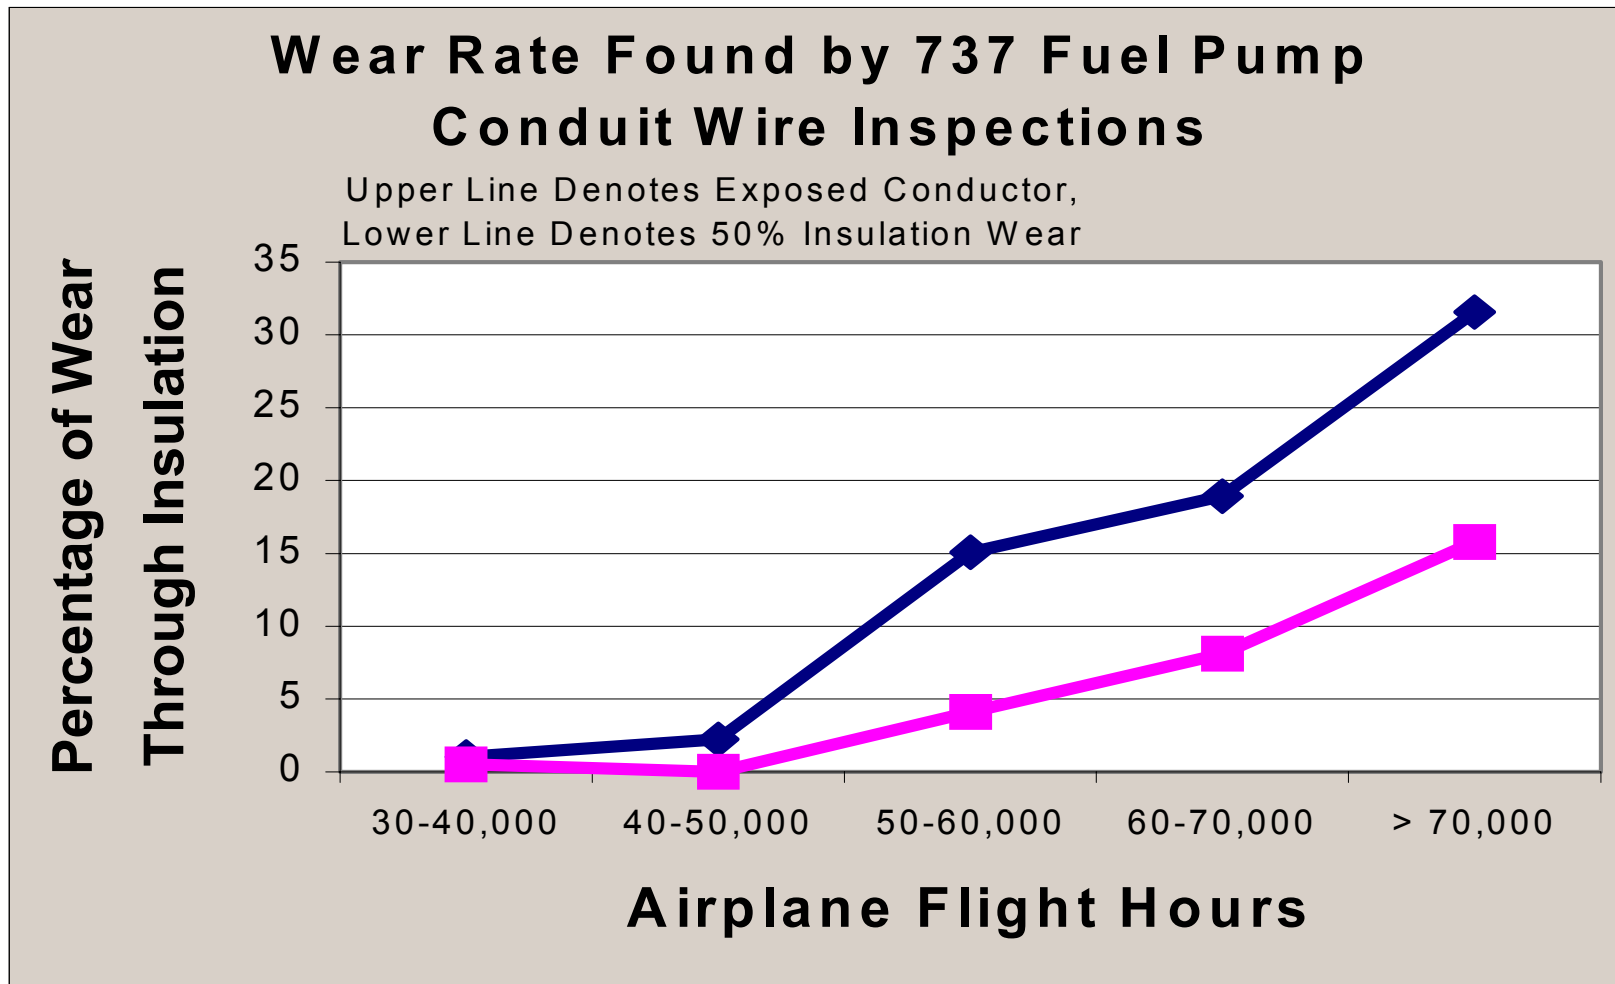
Figure 39. A chart showing the 737 fuel pump conduit wear rate that was identified by the FAA during representative 500 wire inspections.

conduits, on May 10, 1998; (2) AD 98-11-52, which revised the flight-hour requirement outlined in AD T98-11-51 to include airplanes with more than 40,000 flight hours, on June 24, 1998; and (3) AD 99-21-15, which further revised the flight-hour requirement outlined in AD T98-11-51 to include airplanes with more than 20,000 flight hours, on October 8, 1999. Figure 39 shows the 737 fuel pump conduit wear rate that was identified by the FAA during representative 500 wire inspections.⁴¹² Similar data for 747 inspection results were not released.

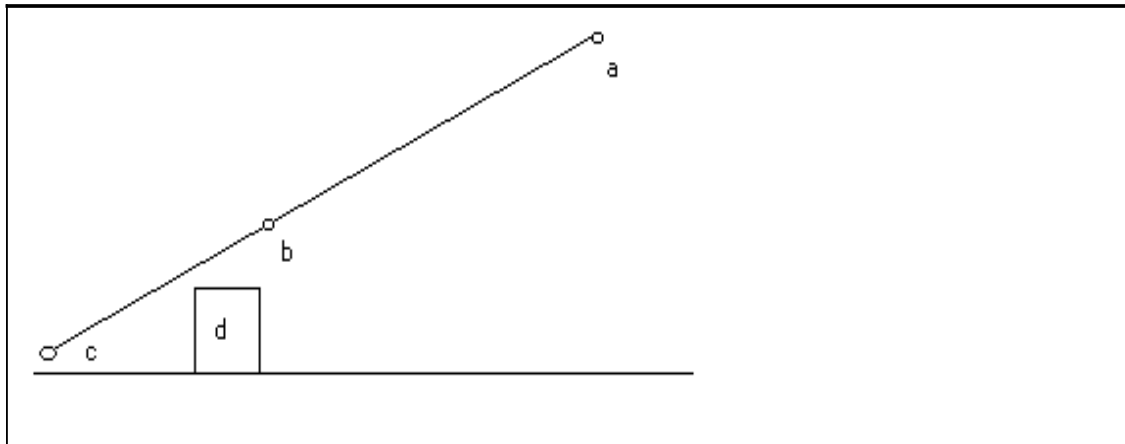
It should also be noted that witnesses observing the accident from Long Island would have been viewing it against a featureless background and, therefore, would have had few, if any, depth perception cues. Consequently, because of the tendency to perceive more distant objects as being about the same distance away as intervening objects (the equidistance tendency), the streak of light could have appeared closer to them than it actually was. The equidistance tendency is illustrated in figure 45, which depicts a person at point “c” observing an object at point “a” that appears at point “b” at the same perceptual distance as an intervening building at point “d.”

This phenomenon possibly explains why the witness on the Beach Lane Bridge stated that the streak of light came into his view just above the roof of a house and why he reported that it appeared to have originated on the beach just beyond that house. For some observers, the equidistance tendency would have caused the streak of light to appear lower

Figure 45. A graphical illustration of the equidistance tendency.

in the sky than it actually was, which explains why the streak of light may have been reported by some witnesses as having originated at the surface of the earth. It should be noted that almost all of the witnesses who reported that the streak of light originated at the surface viewed the streak of light on the far side of intervening terrain features, such as houses or the barrier island. These witnesses would have perceived the streak of light to be about the same distance as the intervening object because the elevation angle of the object would have been perceptually reduced.
